2010 CICA Lift of the Year Awards

Category B (Cranes up to 130t capacity)

Applicant: Kelly's Crane Hire Pty Ltd
ABN 86 103 554 196

Job Location: Rex Range Road, Rex Highway
1.5 hours north of Cairns

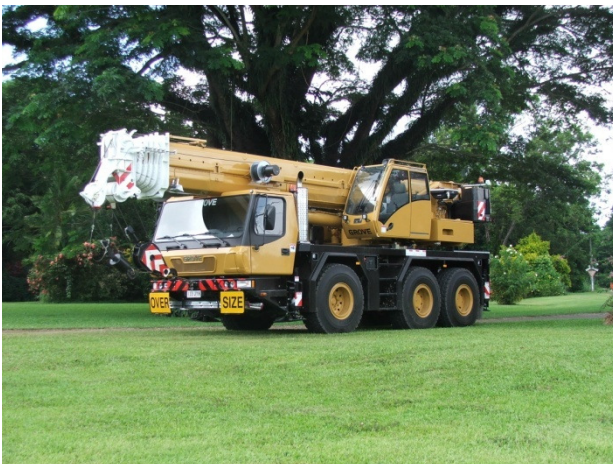
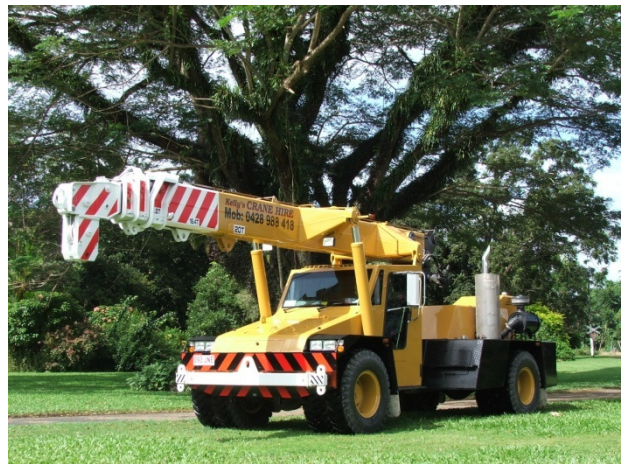
Our lift is the recovery of a 25T bridge girder and dolly which left the road along the Rex Highway approximately 1.5 hours north of Cairns. On 20 October 2009 a convoy of 4 trucks were transporting the first bridge girders from Cairns to Cooktown for the new Endeavour River Bridge. The first truck did not negotiate a sharp uphill bend wide enough and the wheels of the dolly ran over the kerb onto sloping ground. The weight of the 25T girder pulled the load clear of the truck, and the dolly, with the girder still attached, slid several metres into a gully.

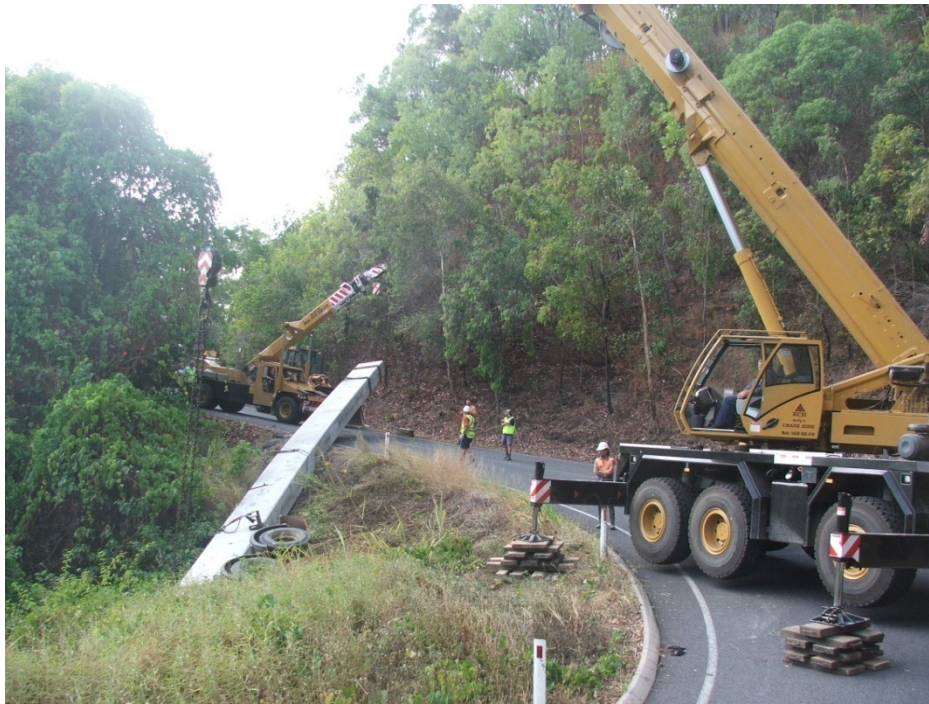
The job was planned to create a pivot point as close as possible to where the girder was in contact with the pavement. This was approximately half way along the girder and the weight of the top half of the girder would act as a counterweight. Two timber packers were used to create the pivot point. Timbers were also used at the top end of the girder for when the girder was righted so that it would not come in contact with the pavement and would act as a second pivot point for when the girder came into radius to lift one end.

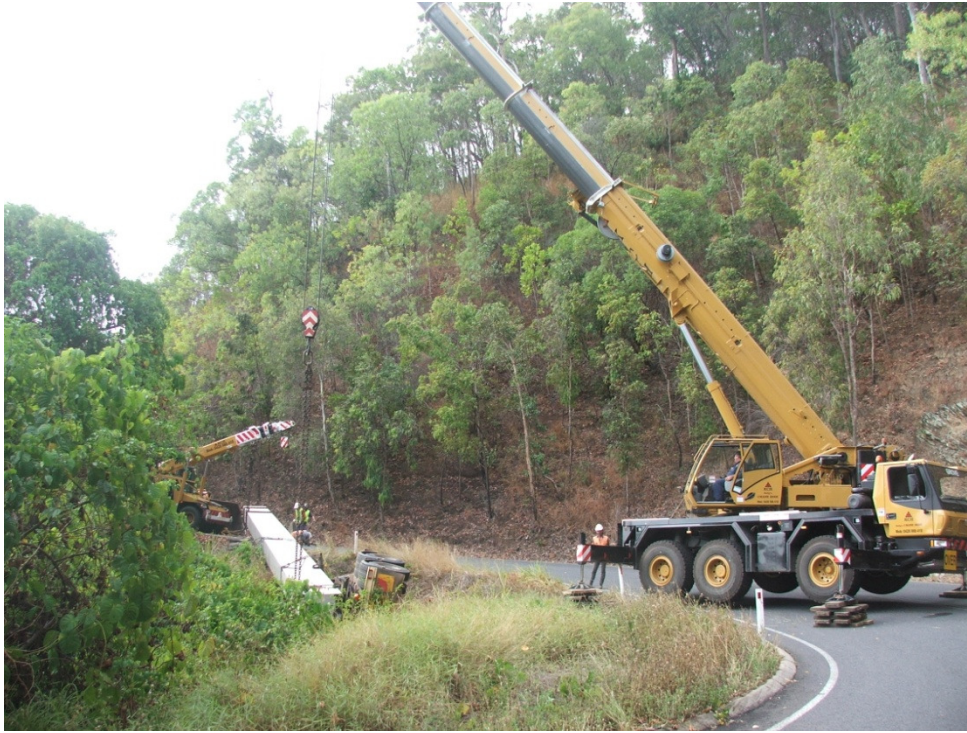
Prior to the lift commencing the Franna and loader drivers were instructed to follow the load rather than applying weight as this would overload the main crane. The Franna and loader were purely to secure the load and act as an anchorage point to prevent any sudden movement or slippage of the girder while the main crane brought the girder into a radius of 8m.

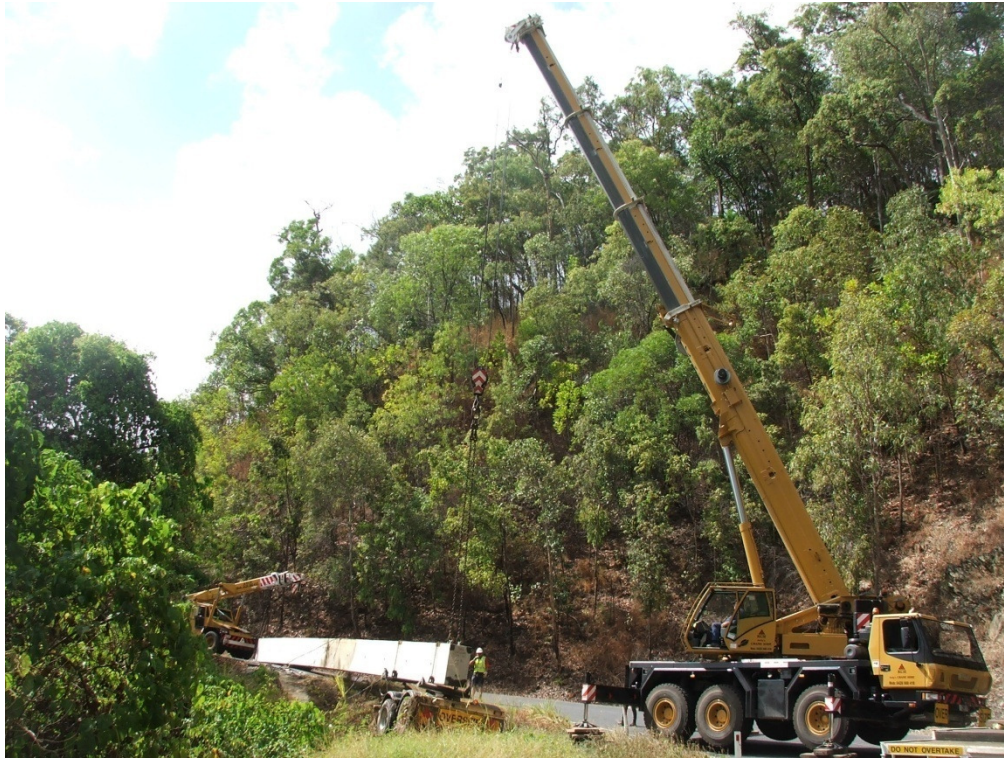
When the end of the girder made contact with the end pivot point the crane slewed until the wheels of the dolly could be placed onto the pavement. The wheels were chocked to stop any downhill movement before the full weight of the girder was released.

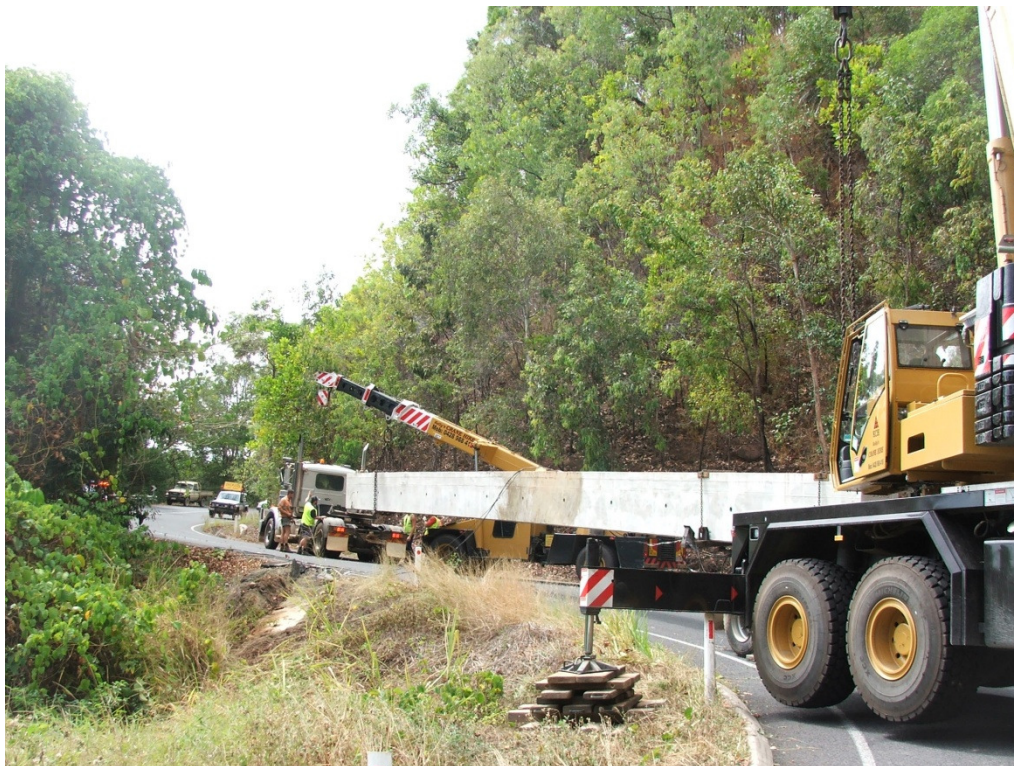
The Grove was no longer required and the 20T Franna was re-positioned to lift the front end of the bridge girder. It was attached to the 36T set of 2-legged chains with a 2.5m radius where the crane was good for 13.9T. The truck reversed under the girder and it was re-attached.
